New Technology for Deep Horizons Chemical Grout Injection.

A discussion of what Polymer Technologies Worldwide, Inc. has brought to the industry.

Mark Richter, PE of Richter Engineering, Inc. is pleased to offer an independent review of the technology and services offered by Polymer Technologies Worldwide, Inc. and how it differs from other technologies and methods of chemical injection.

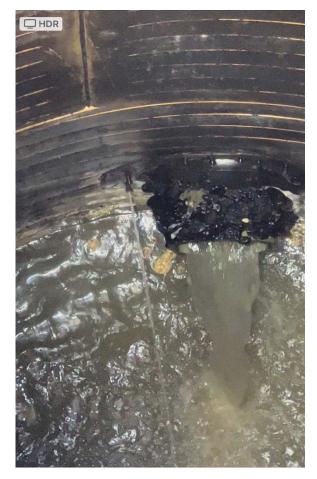
This picture shows the wet-well leak adjacent to the influent pipe. Note stream to the left of influent stream.

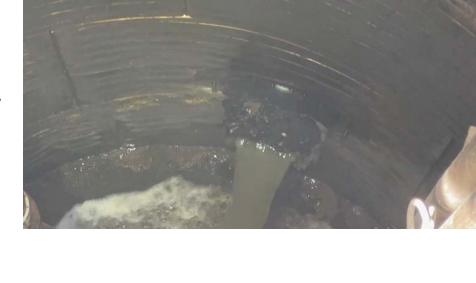
Within 15 minutes of commencing to inject material into the first point we can see that the wet well is already being sealed. Note the absence of the leak to the left of influent stream.

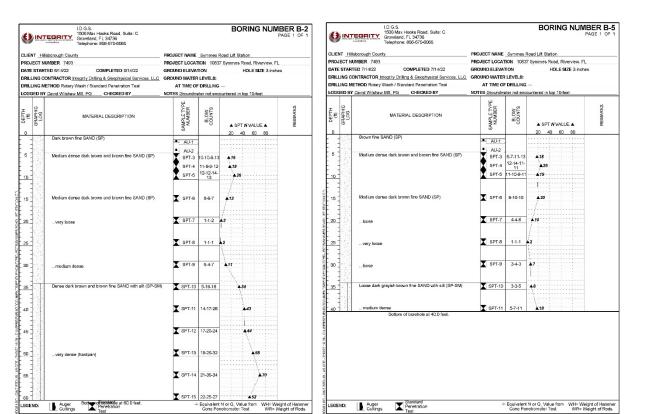
Boring B-2 is the pre-injection condition and B-5 is a post-injection condition. These borings are located between the compound fence and the property line for the lift station property.

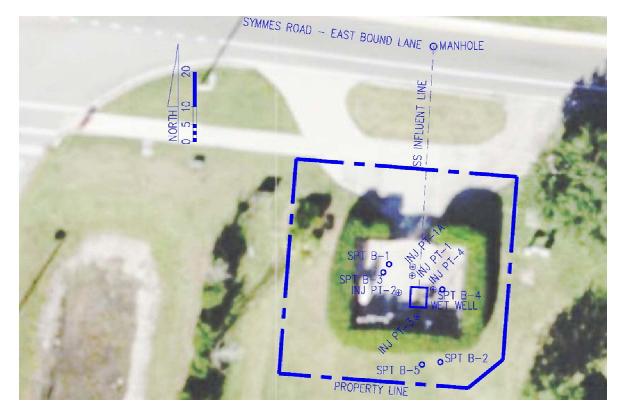
This depicts the site map for the Symmes Rd lift station project

Injection point #1 is located approximately one foot east of B-1 and approximately three feet west of the influent line (influent line runs north to south into the wet well) on the north side of the wet well. Injection point #1 received 119 gallons of material starting at a depth of 38 feet. Injection point #1 experienced an equipment issue and was abandoned at a depth of 25 feet. Injection point #1A was located 1 foot north of injection point #1. Injection point #1A was advanced to a depth of 24 feet and received 710 gallons of material as withdrawn up to the surface. Injection point #2, located west of B-3, was advanced to 35 feet in depth and received 709 gallons of material as withdrawn up to the surface. Injection point #3, located south of the wet well and approximately 19 feet north of B-5, was advanced to 31 feet deep and received 425 gallons of material as withdrawn up to the surface. Injection point #4 was located east of the wet well approximately 3 feet north of the lift station ejection/effluent pipe. Injection point #4 received 779 gallons of material as withdrawn starting at a depth of 41 feet below grade up to the surface.

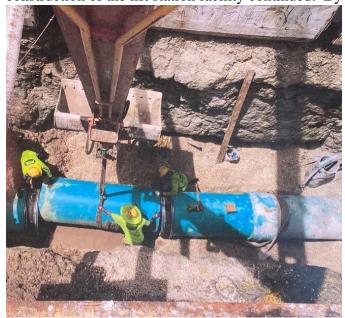
This was taken when the subject pipe was initially installed.

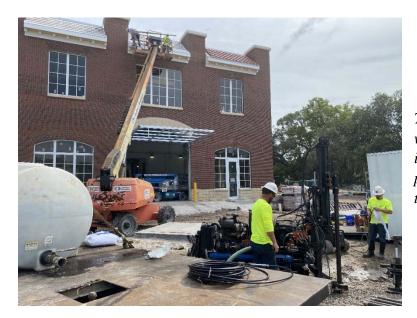
The prime contractor continues work uninterrupted on the infrastructure while injection of polymers for the purpose of sealing the leaking buried line.

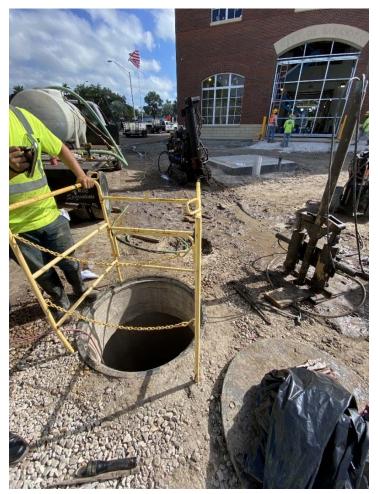
Another view of concurrent injection points along with work continuing on project by prime contractor. Injection points are on alternate sides of the subject pipeline.

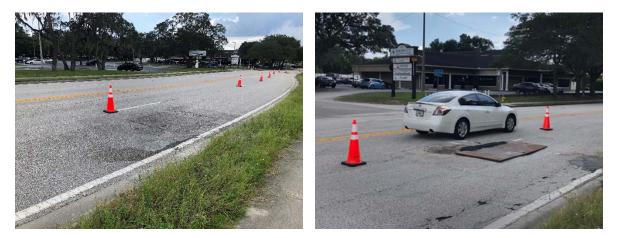
Oakfield Dr. near Bob Dykes Dr. Looking towards southwest from north side of roadway.

The series of manholes is located on Oakfield Drive between Pauls Drive and Kings Avenue have leaked and caused partial collapses of the roadway. The leaks is located adjacent to the manholes where one of the lines enters/exits.

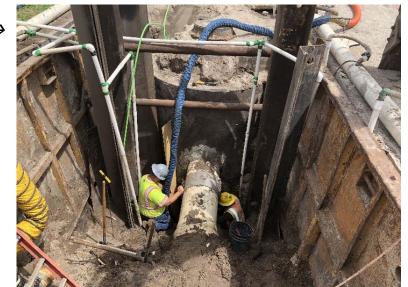
The problem: leaking joint at manhole results in a depression in the roadway which can lead to a localized collapse if left unrepaired.

The typical culprit would be a leak between manhole and pipe. Another typical leak location is between the first and second pipe segment. Oakfield Drive leak repair \rightarrow
